Heather Gardens

ASSOCIATION

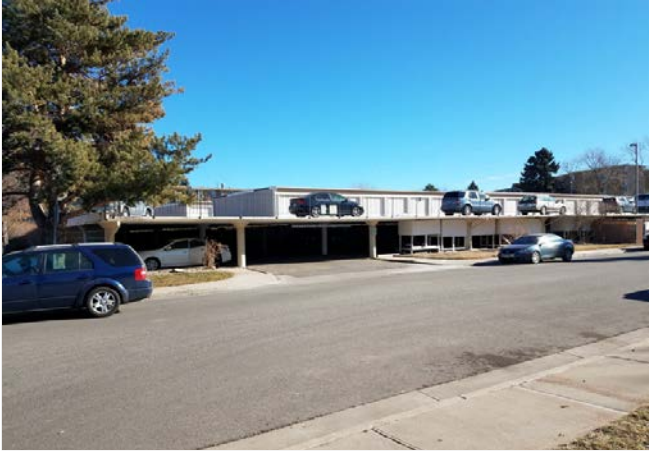
Photo 2 – Perimeter railing at Structure #2. Typical of perimeter railings at all structures.

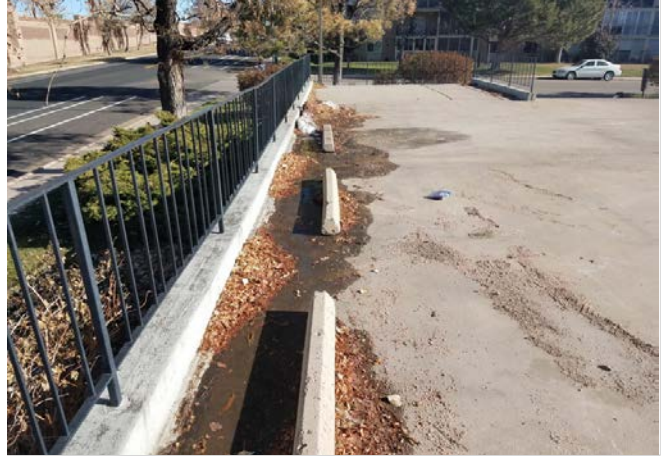
Photo 3 – Traffic coating at the perimeter and asphalt patch material at slab spalling..

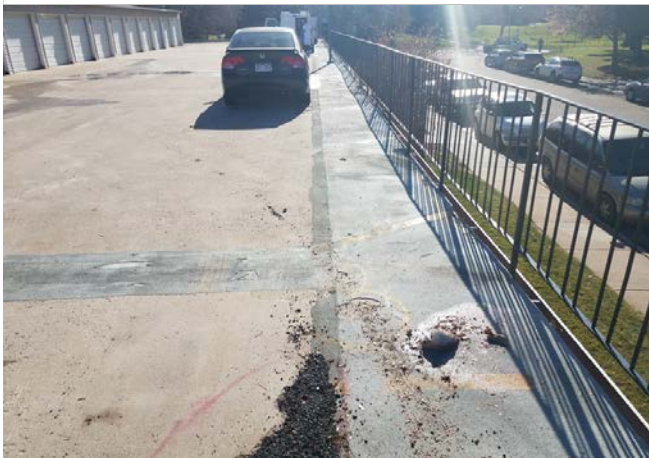
Photo 4 – Perimeter railing with welded post repair and deflection from impact.

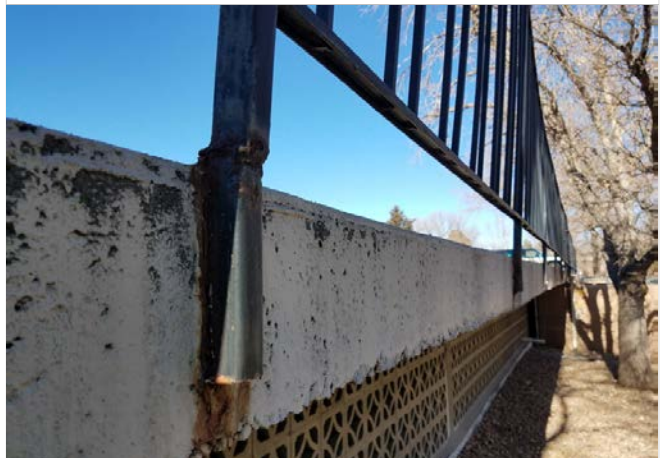
Photo 5 – Typical stair layout and railings.

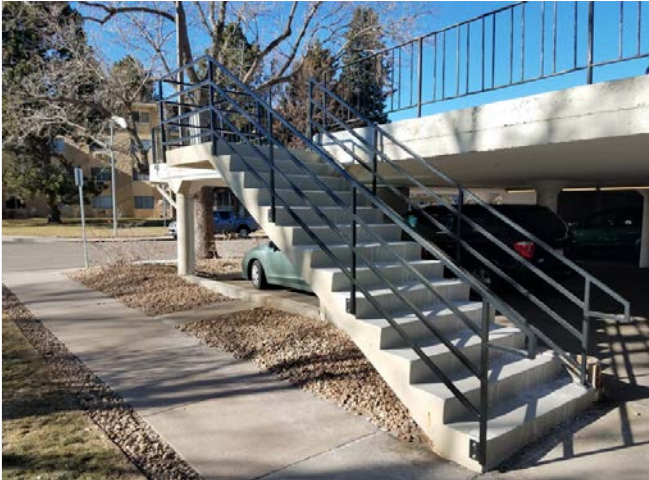
Photo 6 – Damaged CMU light units at top of wall at perimeter foundation wall.

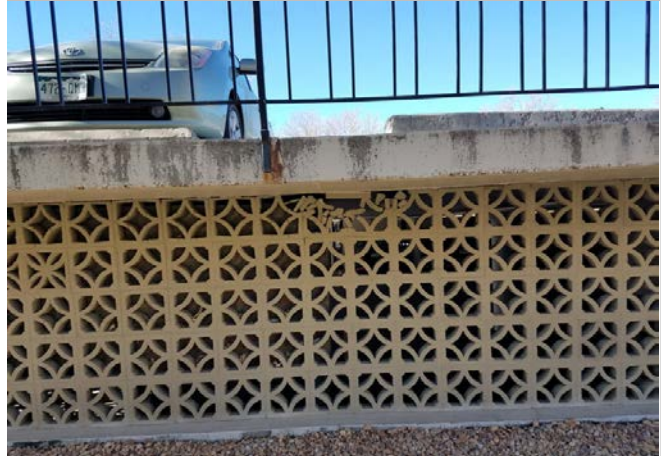
Photo 7 – Severely deteriorated concrete at the west edge of Structure #2.

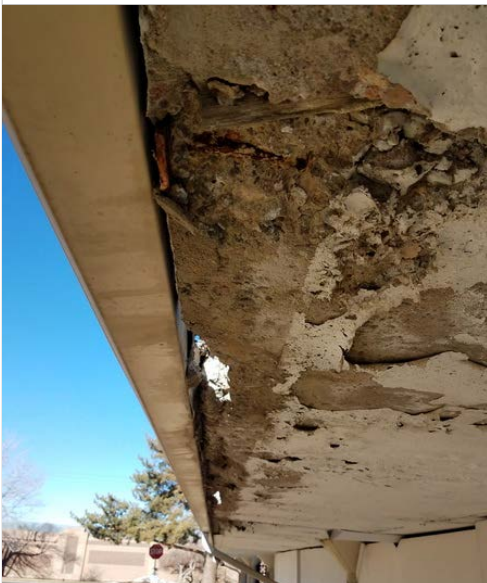
Photo 8 – Typical concrete spall at column.

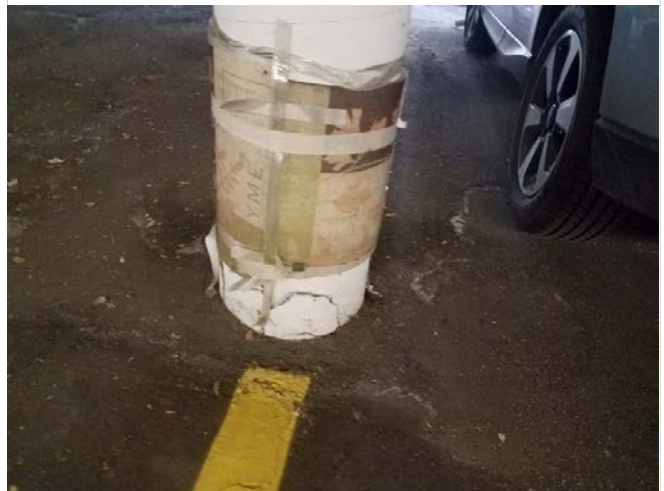
Photo 9 – Crack at parking structure soffit. Note peeled paint and staining indicating moisture migrating through the crack.

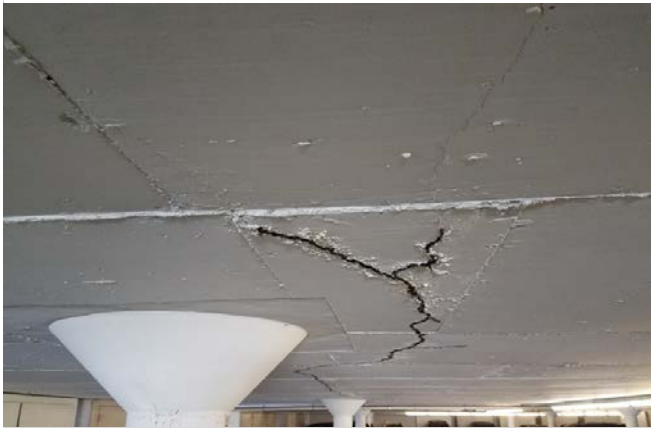
Photo 10 – Spalled concrete at supported slab with corroded rebar and failed PT tendon.

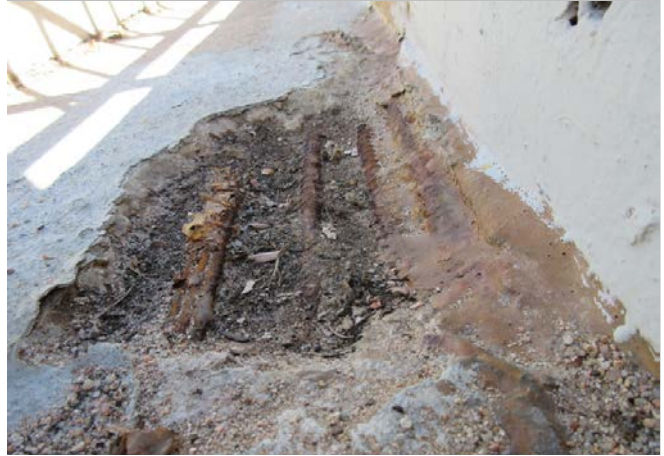
Photo 11 – Stains at perimeter foundation wall indicating leakage through the wall.

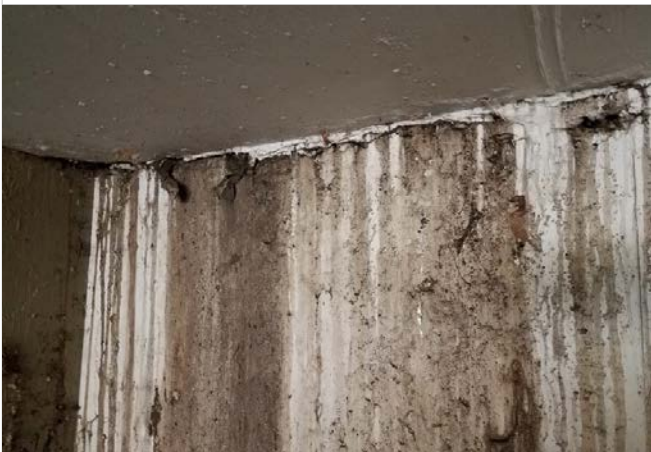
Photo 12 – Failed joint sealant on supported slab.

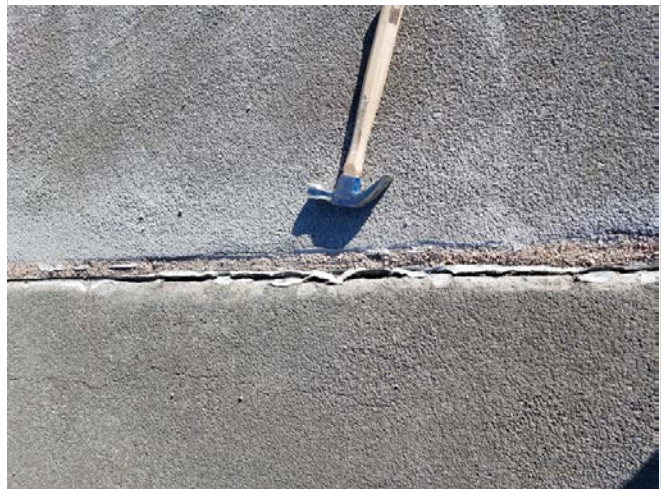
Photo 13 – Failed joint sealant at overlay inside a metal building enclosure.

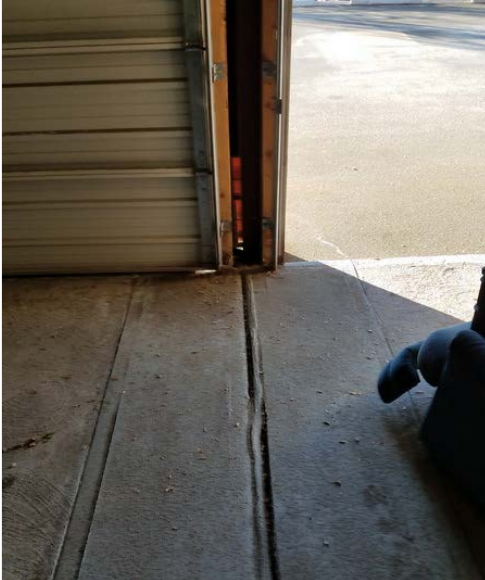
Photo 14 – Cracked and delaminated overlay inside metal building enclosure.

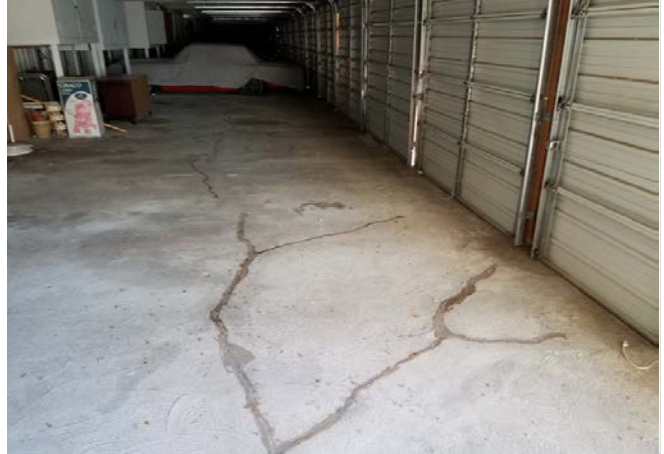
Photo 15 – Damaged siding at meal buildings.

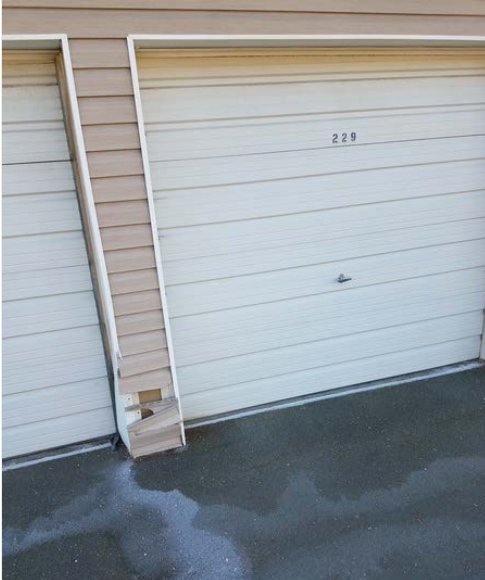
Photo 16 – Damaged façade cladding and corroded structural steel.

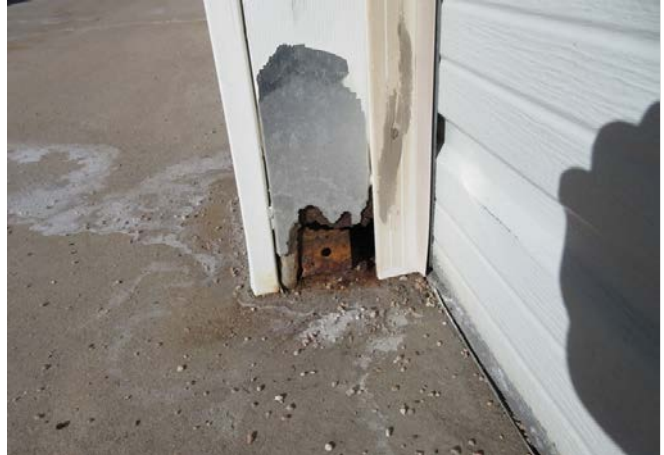
Photo 17 – Corroded structural post and door railings and deteriorating wood framing.

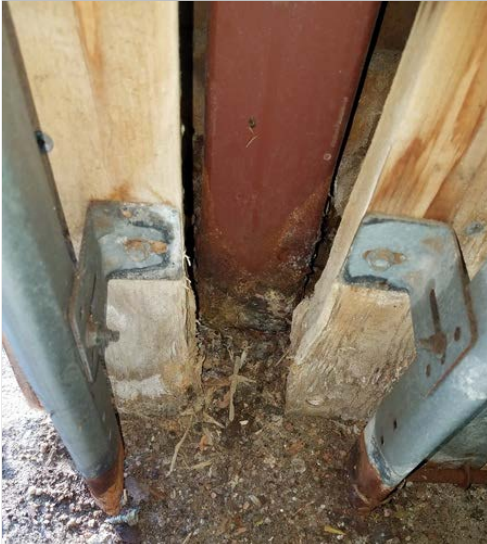
Photo 1 – South end of Structure 2 at typical exploratory openings at PT tendons.

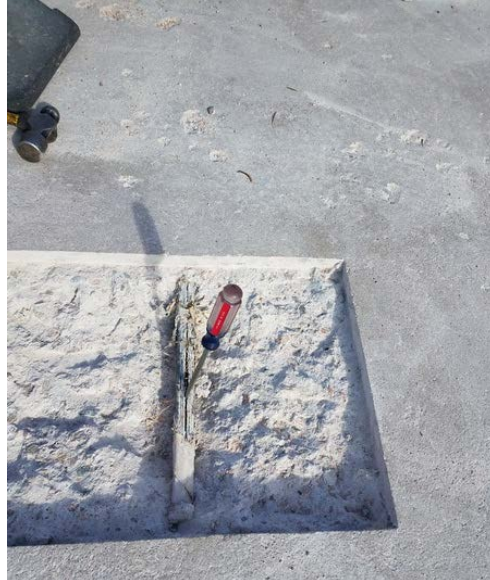
Photo 3 – Failed PT tendons at the anchors due to corrosion.

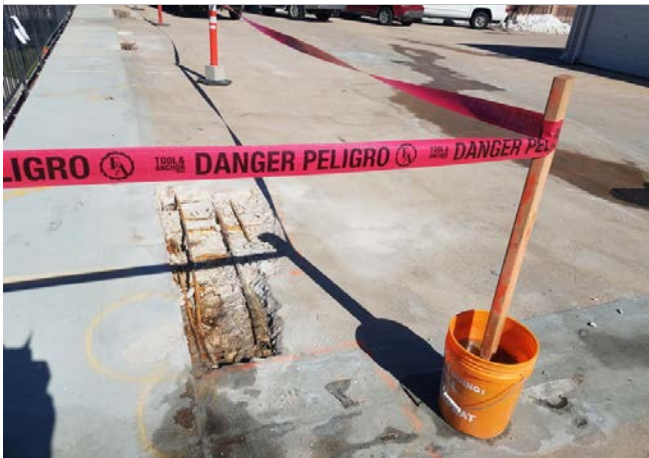
Photo 4 – Typical PT tendon bundle.

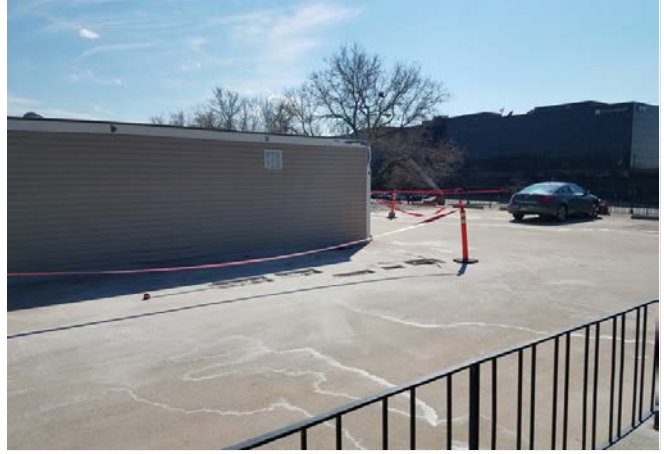
Photo 3 – PT tendon bundles with corrosion present on wires.

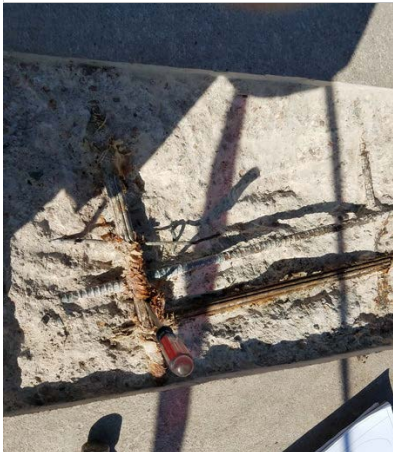
Photo 4 – Corroded PT tendon.

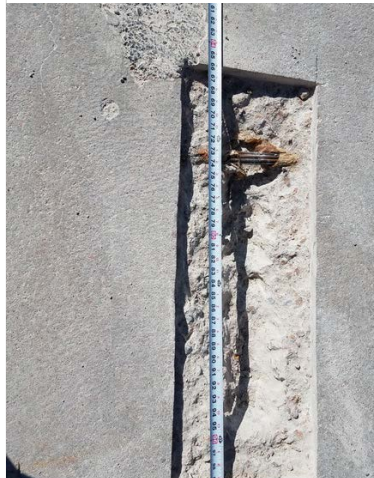
Photo 5 – Severely corroded PT tendon.
